# PROPERTY INSPECTION REPORT

# C.R.INSPECTIONS

1234 Investment Ave. , Your Town , CA  
Inspection prepared for: John and Jayne Doe  
Date of Inspection: 7/14/2015 Time: 2pm  
Weather: Sunny  
SAMPLE REPORT ONLY

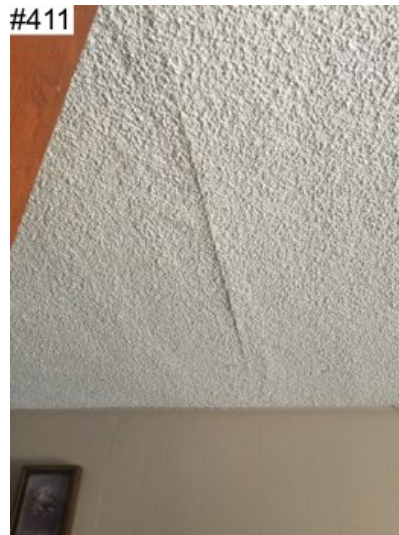
Settling cracks noted.

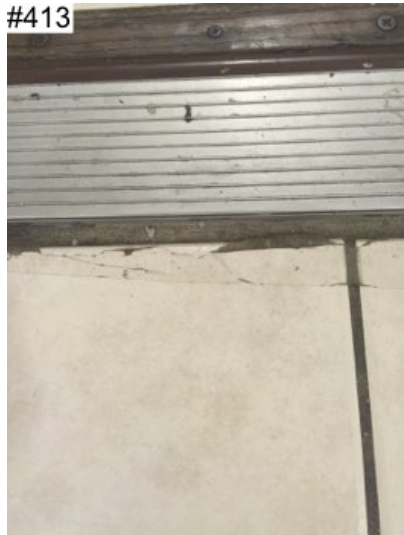
Missing threshold. This can be a trip hazard

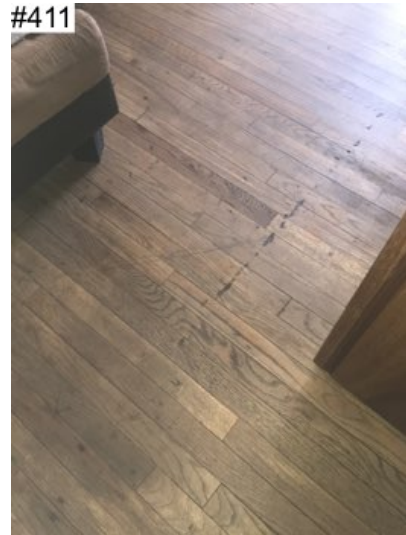
Heavy wear

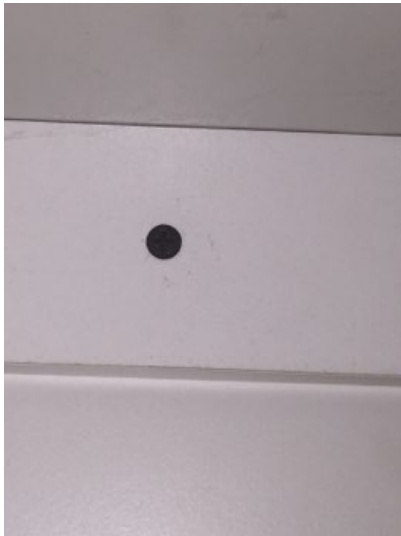
Recommend adding additional cabinet screws as drywall screws have been used.

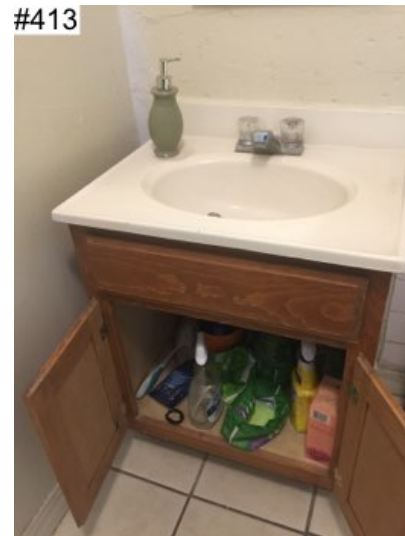
Countertop is not attached to Cabinets

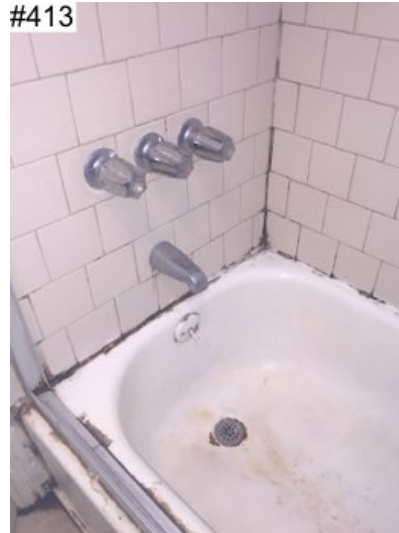
Caulking needed around perimeter.

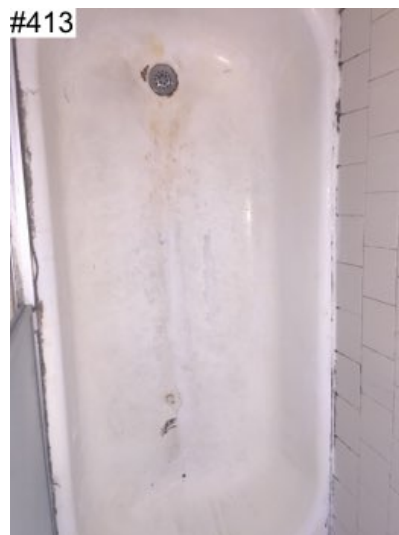
Stains observed.

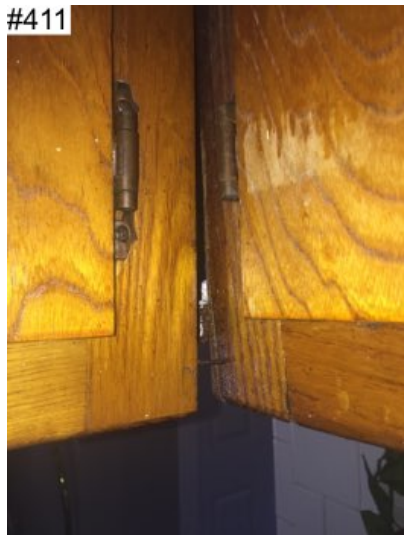
Noted cabinet(s) separating at the ceiling. Recommend having a qualified contractor re-fasten the cabinets. #411

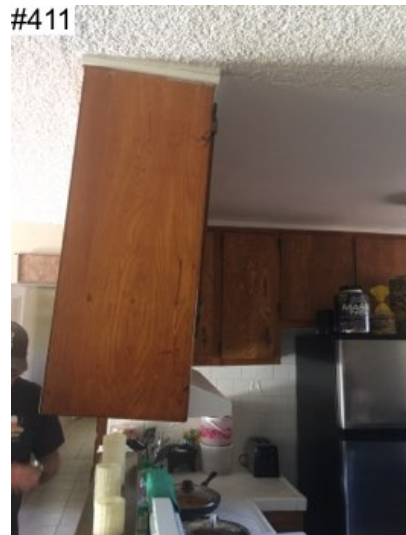
Noted cabinet(s) separating at the ceiling. Recommend having a qualified contractor re-fasten the cabinets. #411

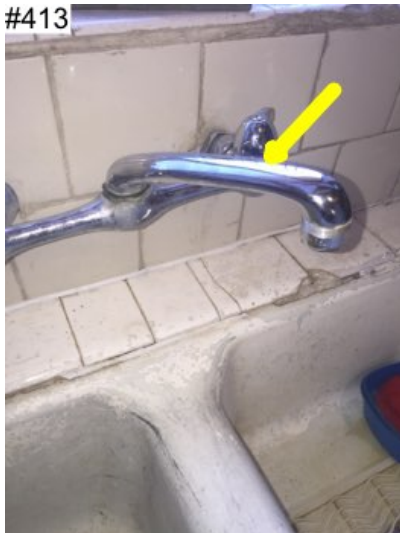
Faucet loose at base.

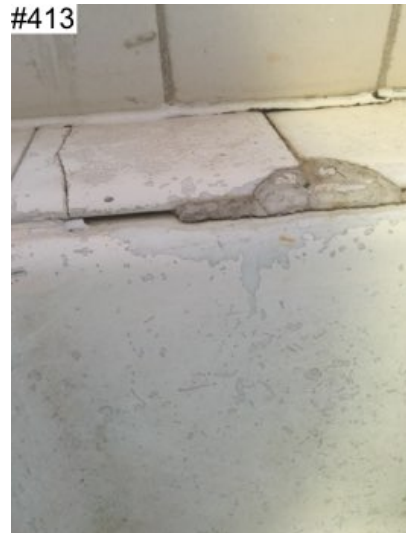
Suggest caulking as necessary.

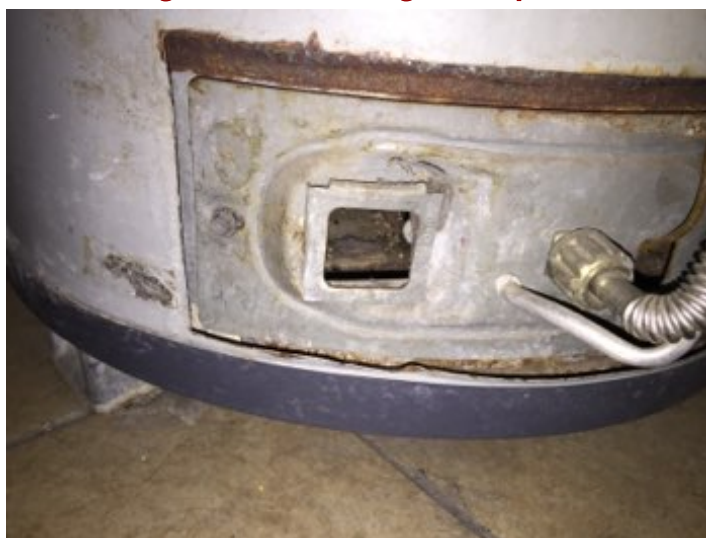
Chamber glass is missing. See photo

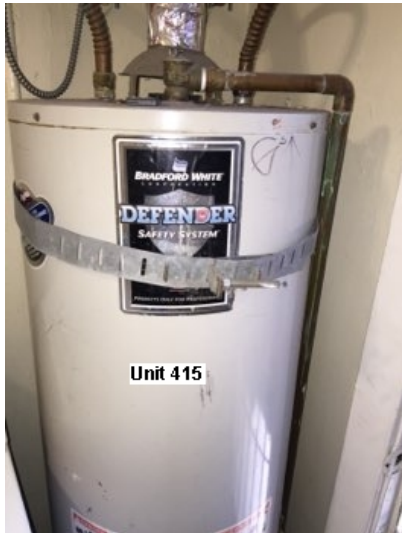
Unit 415

Loose straps noted.

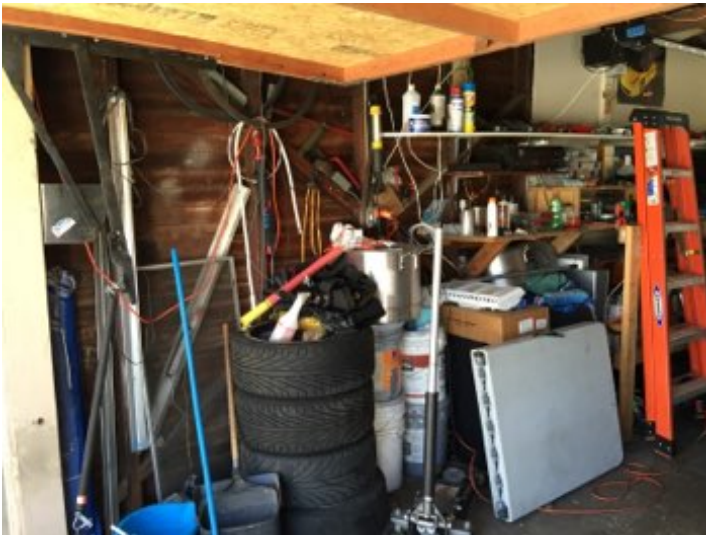
Personal items in garage block complete inspection of all floor, wall and ceiling areas.

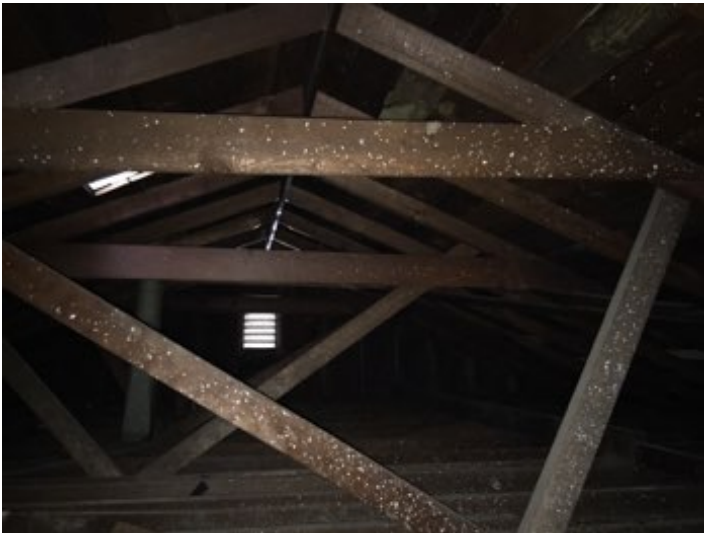
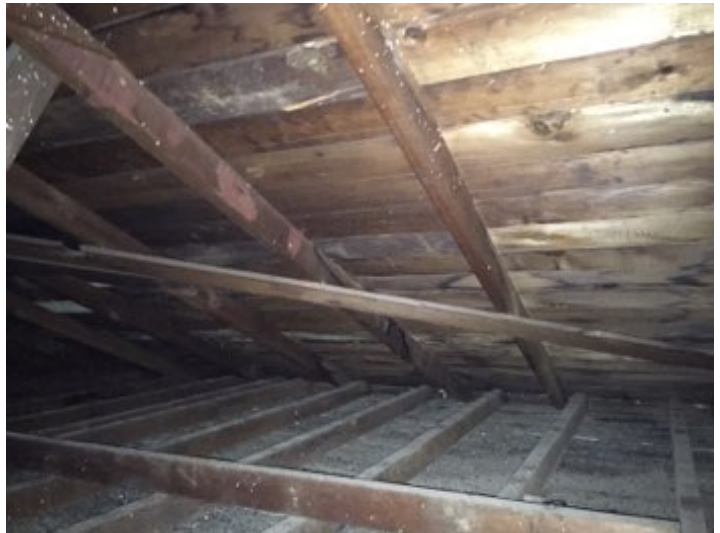
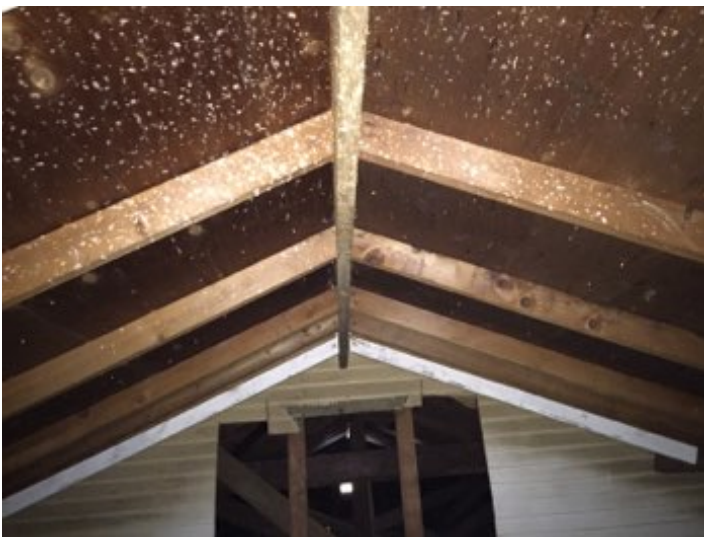
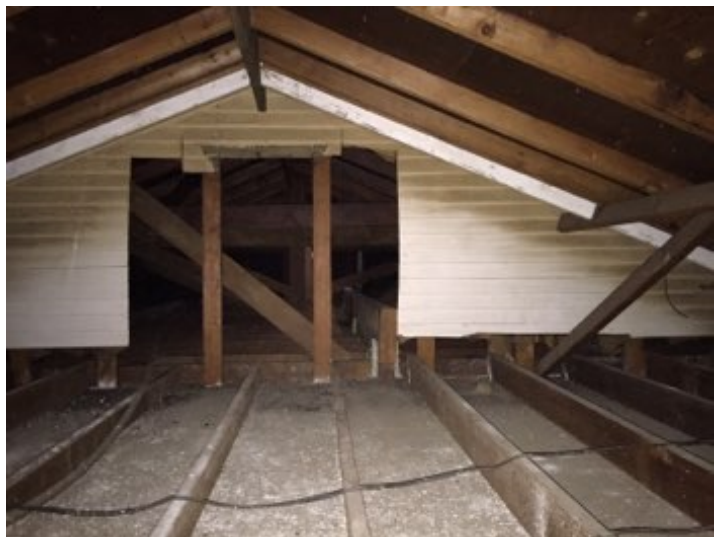
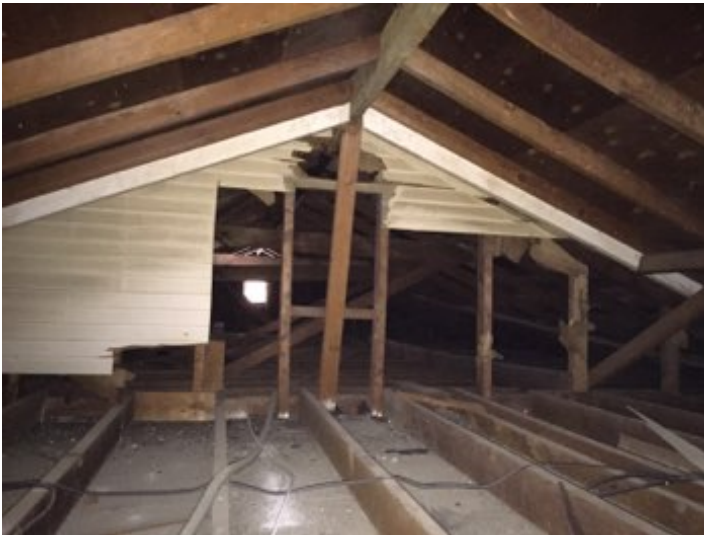
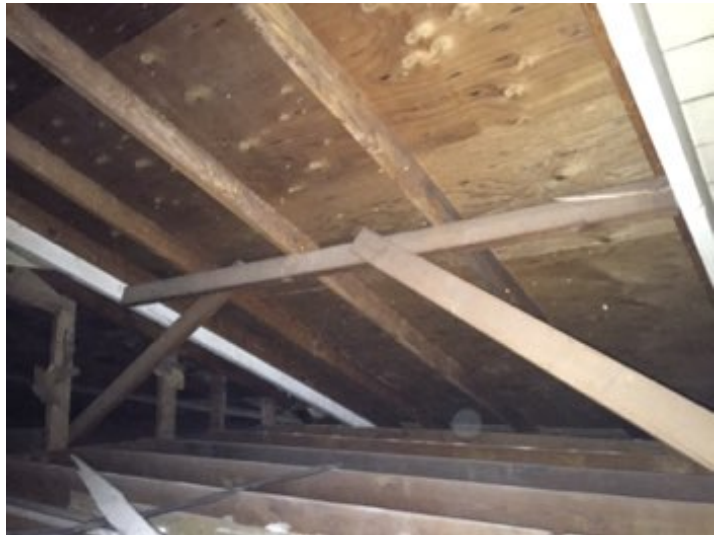
- Evidence of past or present leaks, dry at time of the inspection. Monitor for leaks &/or have roofing contractor evaluate.
- Inspected from access hole only, limited space in attic prevented entry.

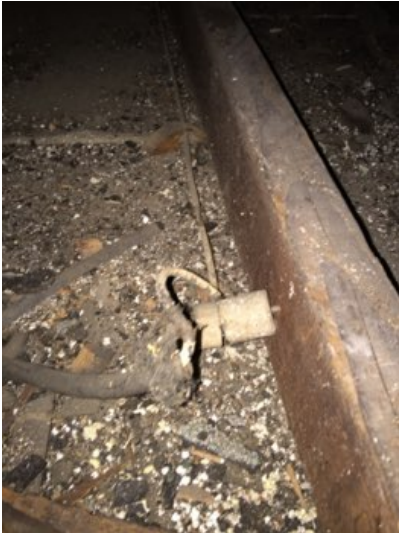
Live knob and tube wiring present.

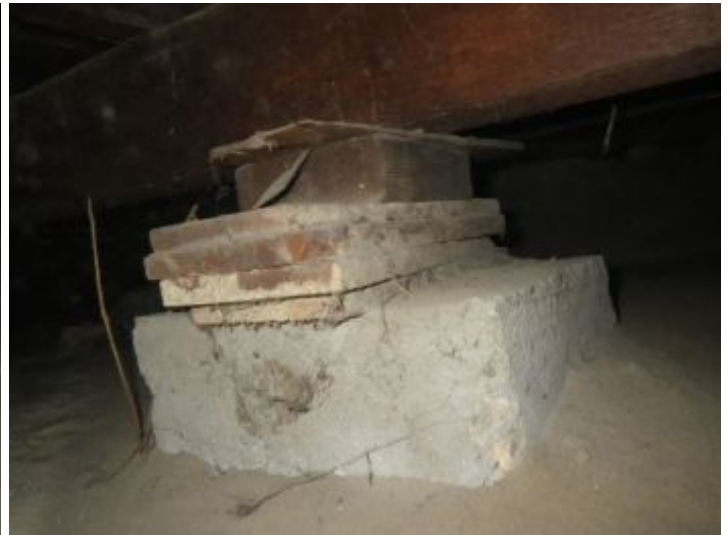
Improper materials used at various posts. see photos

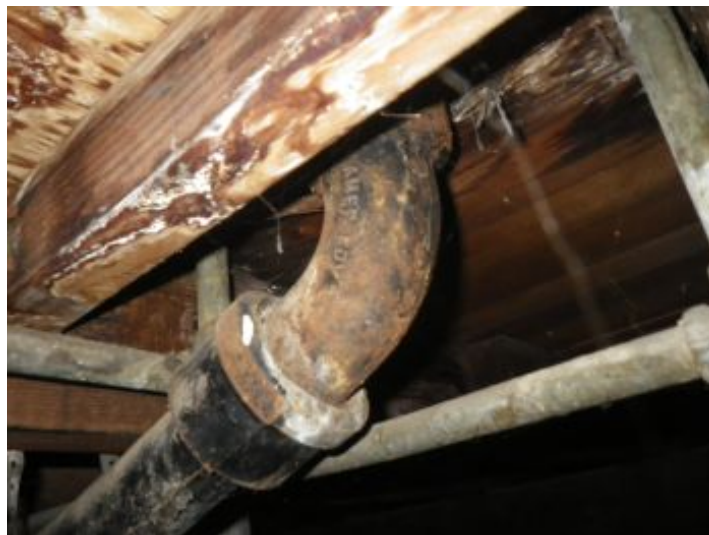
Wood rot, moisture damage observed. consult termite report

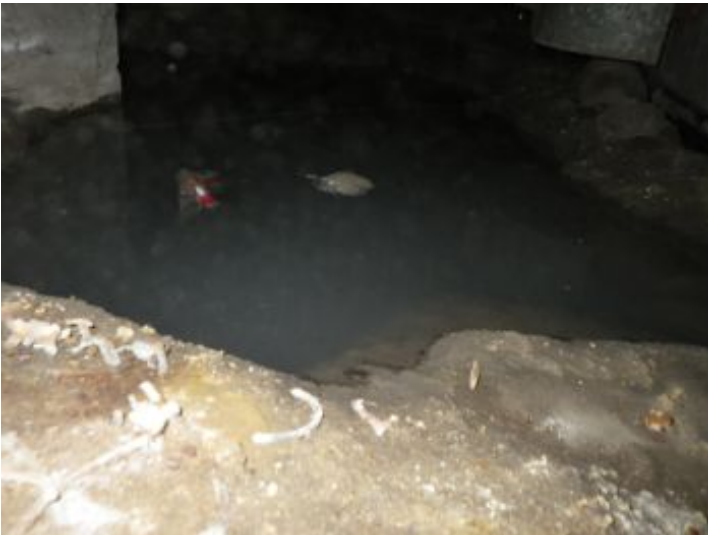
Standing water observed.

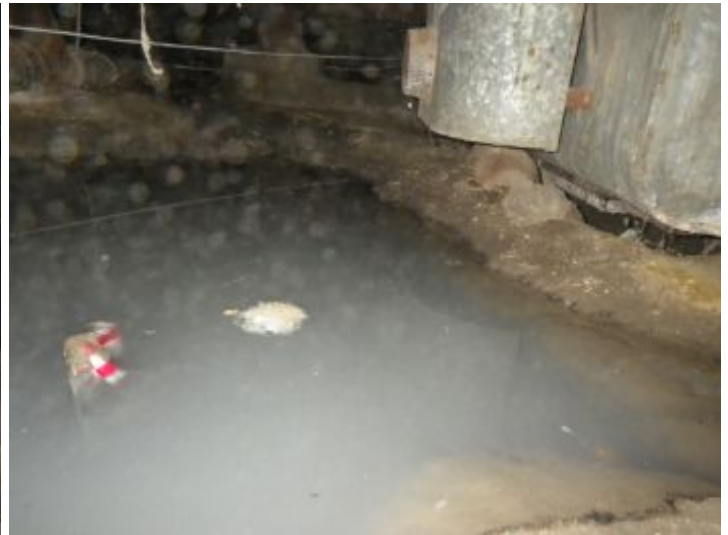
Standing water observed.

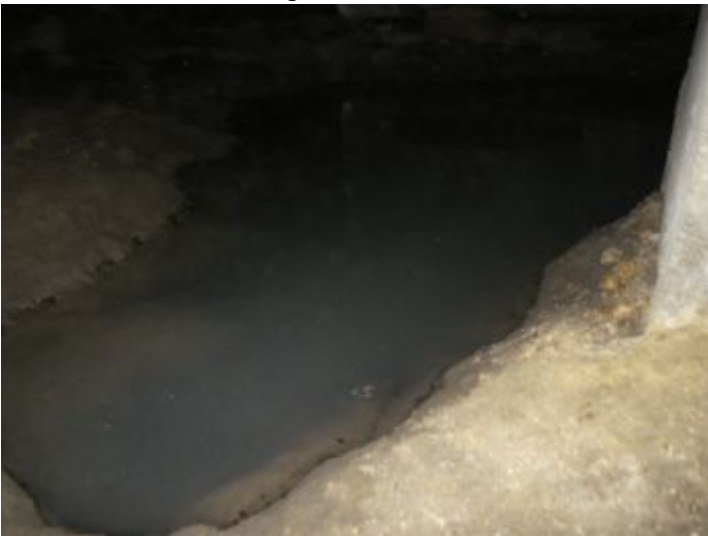
Standing water observed.

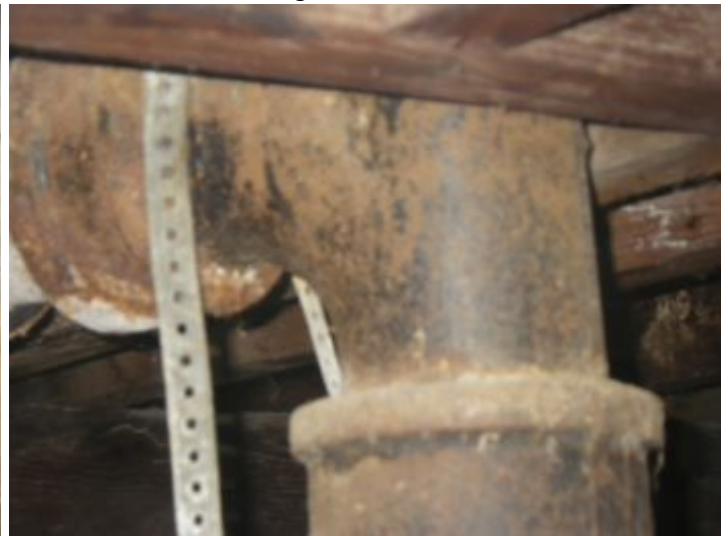
Cast iron drain lines have a life expectancy of 30-50 years. Recommend budgeting for replacement in the near future at areas where rust cysts are visible, BEFORE leaks occur.

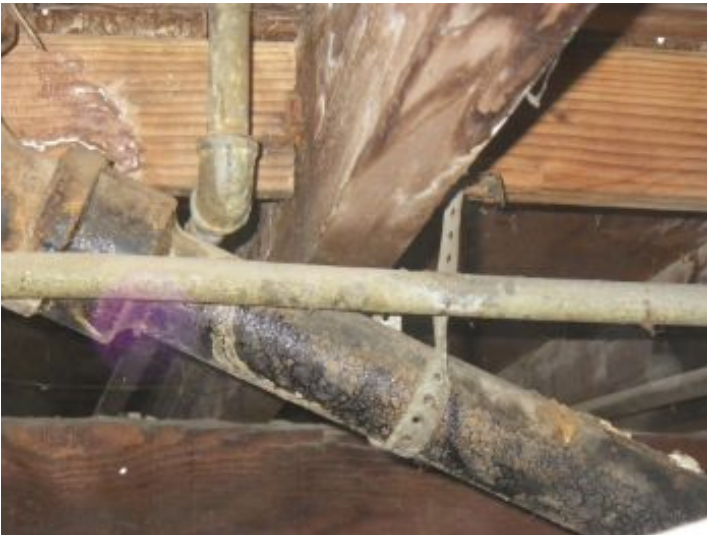
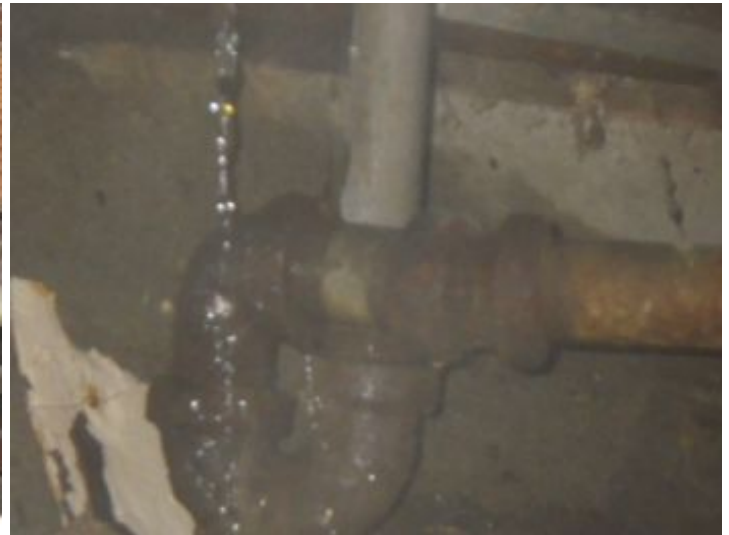
Leaking observed and needs immediate repair by a qualified Plumbing Contractor.

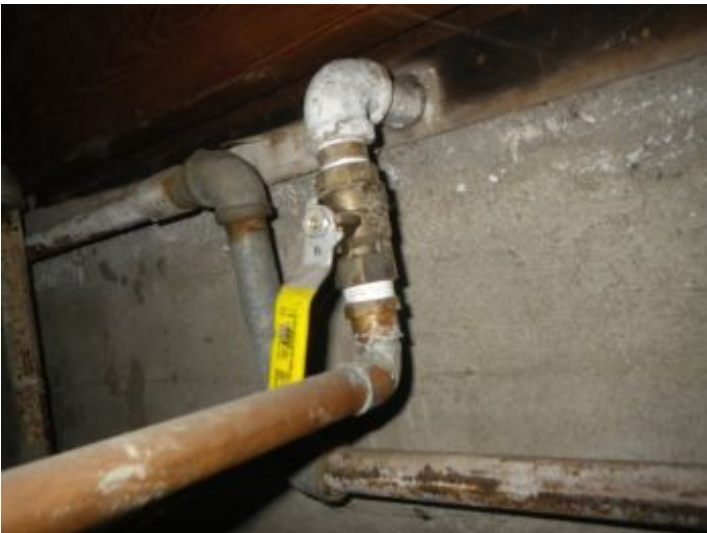
Galvanized and Copper plumbing pipes noted. Copper and galvanized are considered dissimilar metals and over time accelerated corrosion will occur to the galvanized pipe even with a dielectric union present. Minerals in the water provide continuity for electrolysis to occur allowing galvanic reaction to deteriorate the galvanized pipes. Recommend replacement of galvanized pipe by a qualified plumber to prevent leaks due to accelerated corrosion of pipes.

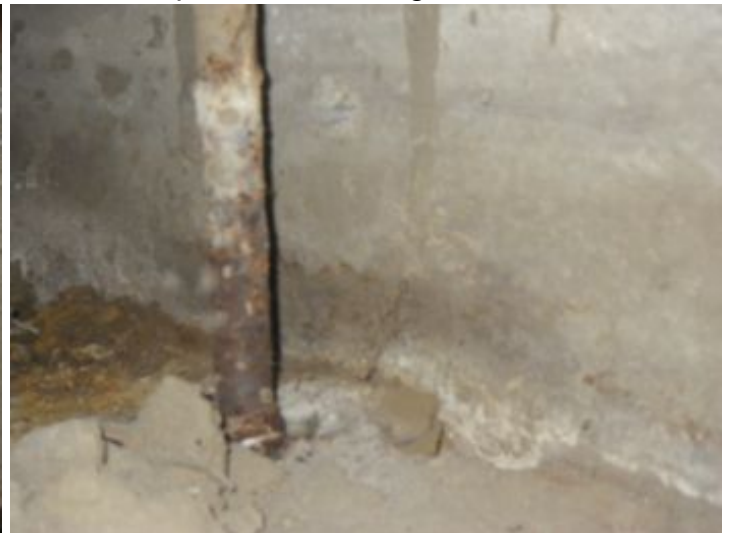
Galvanized pipes present and has an average service life of 30 years. Pipes rust from the inside reducing the diameter and causing loss of pressure and rust in water. Recommend budgeting for replacement of galvanized piping in the near future.

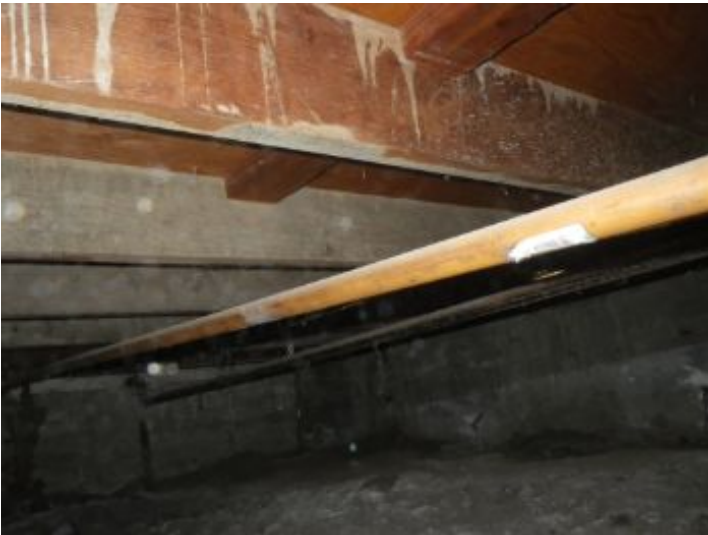
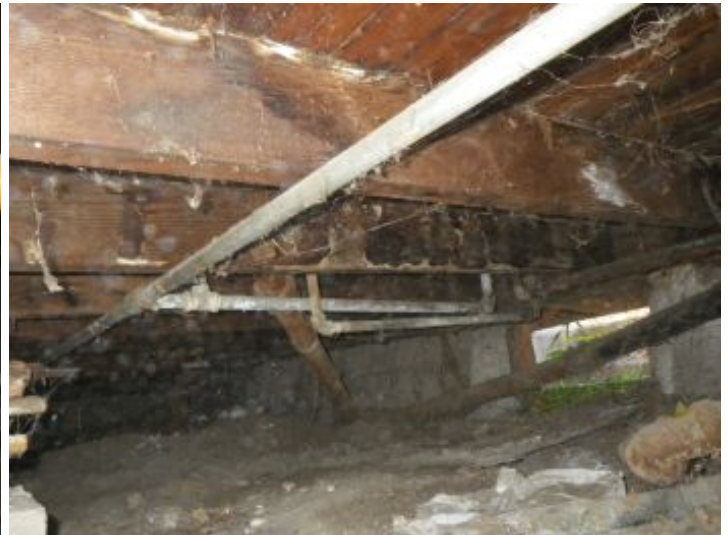
Unsecured supply plumbing observed.

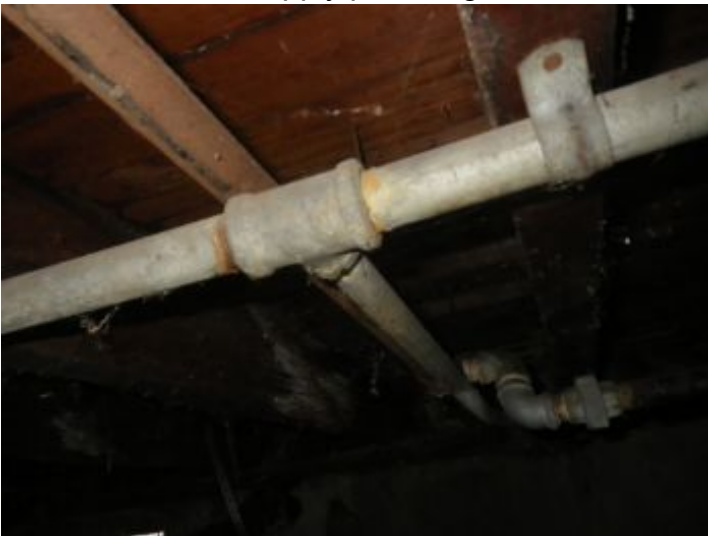
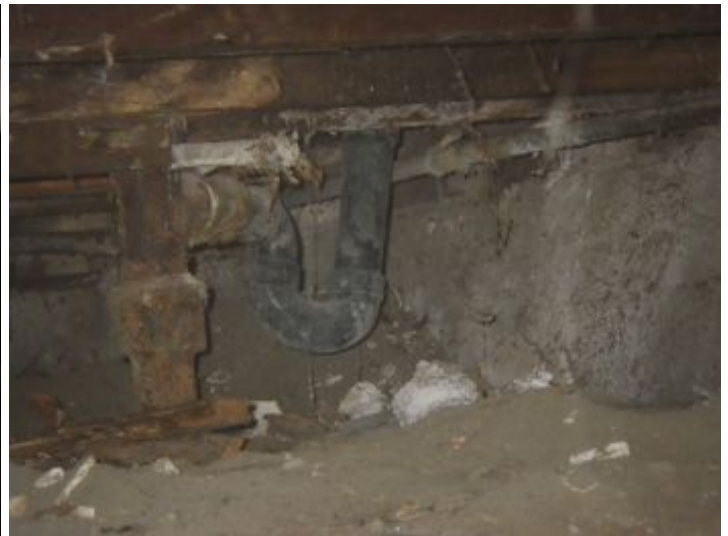
Galvanized pipes present and has an average service life of 30 years. Pipes rust from the inside reducing the diameter and causing loss of pressure and rust in water. Recommend budgeting for replacement of galvanized piping in the near future.

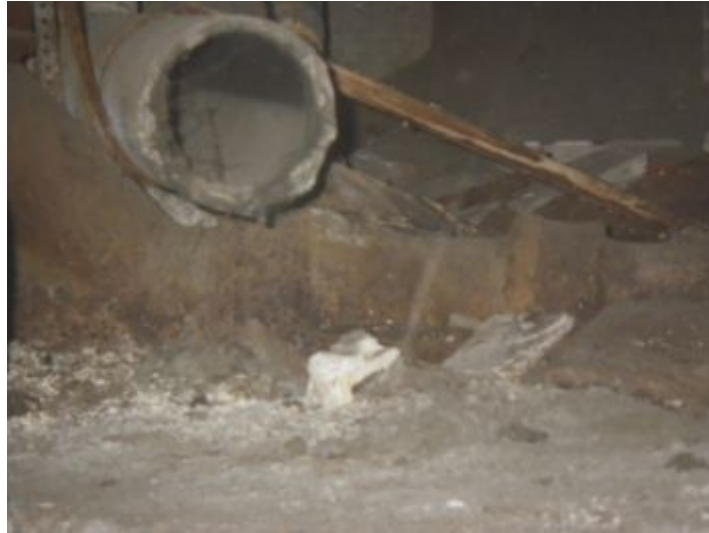
Cast iron drain lines have a life expectancy of 30-50 years. Recommend budgeting for replacement in the near future at areas where rust cysts are visible, BEFORE leaks occur.
