# PROPERTY INSPECTION REPORT

# C.R.INSPECTIONS

1234 Investment Ave. , Your Town , CA  
Inspection prepared for: John and Jayne Doe  
Date of Inspection: 7/14/2015 Time: 2pm  
Weather: Sunny  
SAMPLE REPORT ONLY

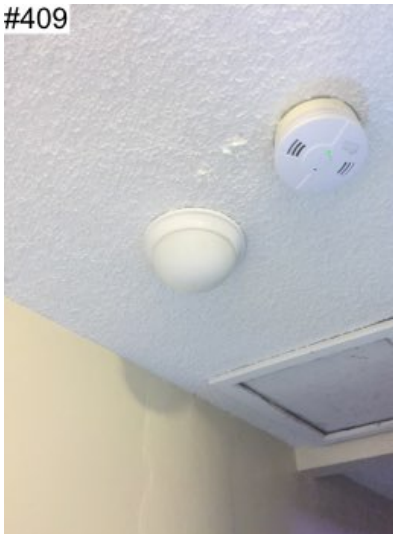
Light in hallway does not operate. Check lightbulb

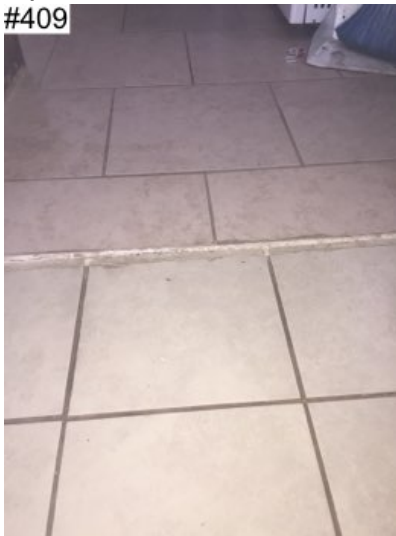
Missing threshold. This can be a trip hazard

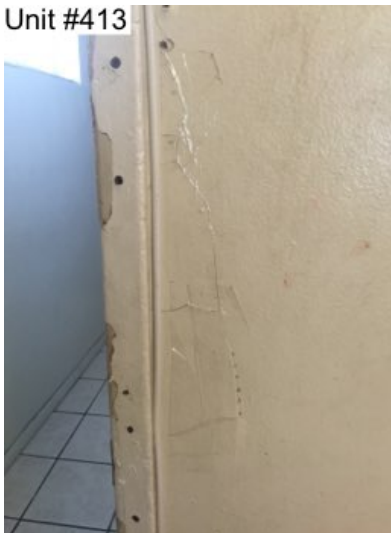
Unit #413

Damaged walls noted.

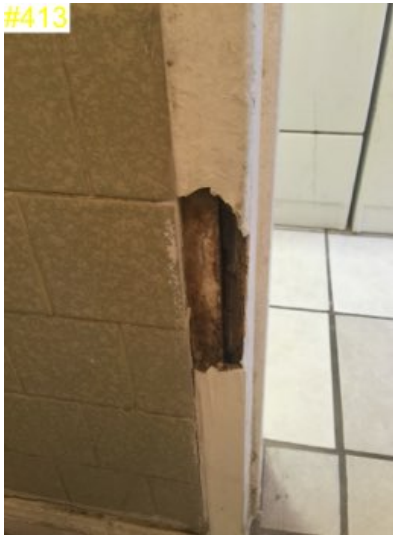
Damage to door frame

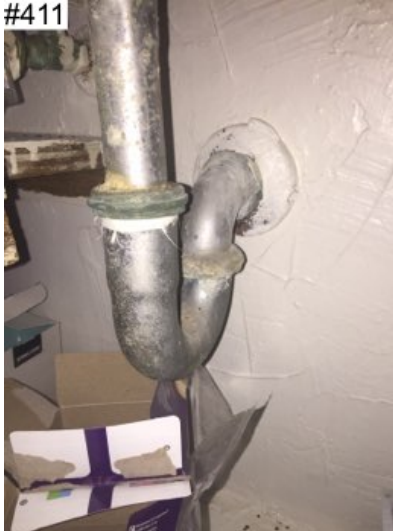
Older style metal traps noted. Buyer is cautioned that these traps can leak at any time due to corrosion.

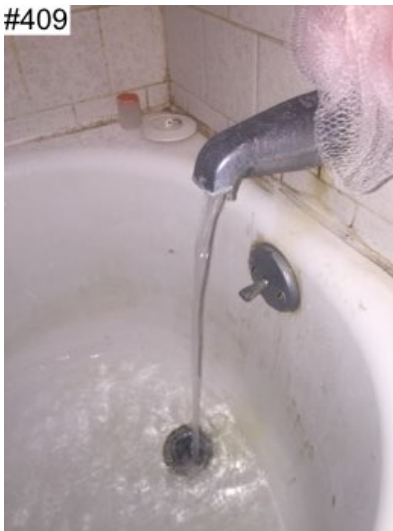
Shower diverter does not fully engage.

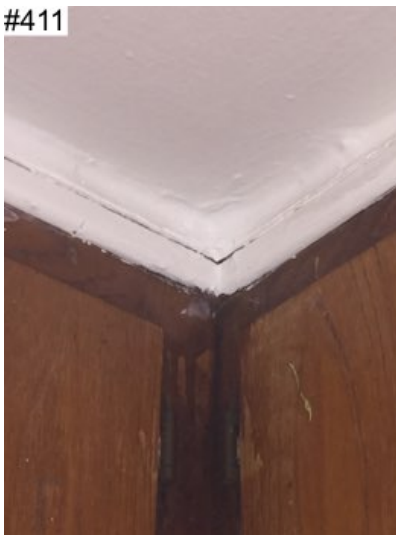
Noted cabinet(s) separating at the ceiling. Recommend having a qualified contractor re-fasten the cabinets. #411

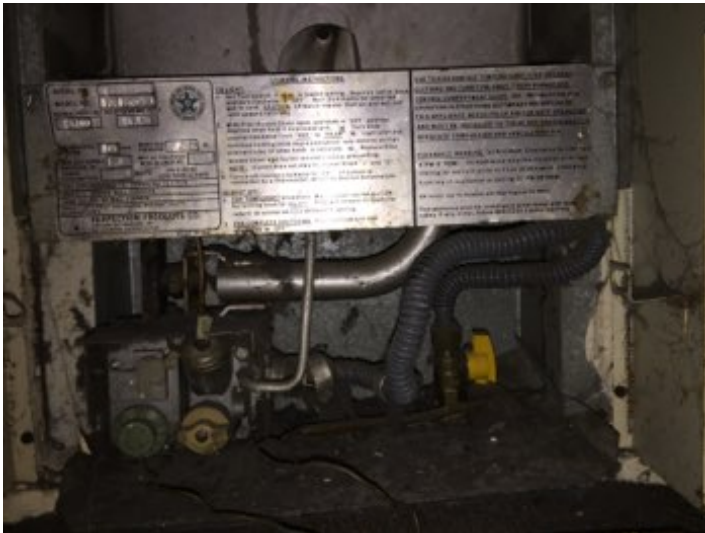
The heating unit has reached its designed life expectancy. We make no warranty, guarantee or estimation as to the remaining useful life of this unit.

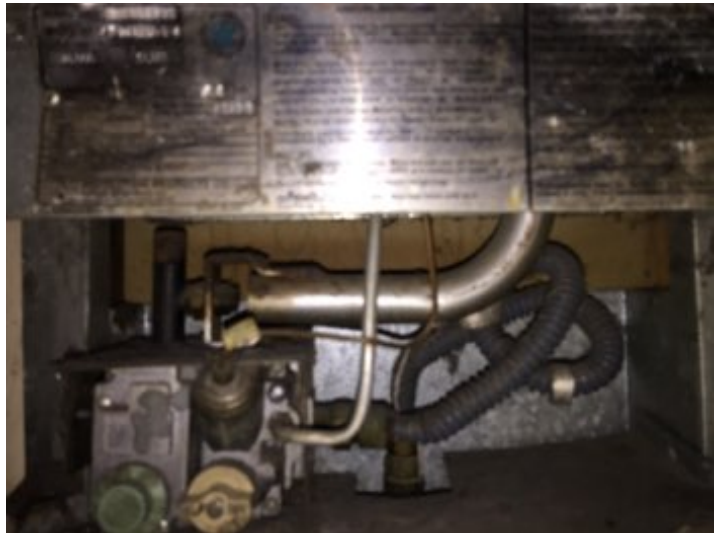
The heating unit has reached its designed life expectancy. We make no warranty, guarantee or estimation as to the remaining useful life of this unit.

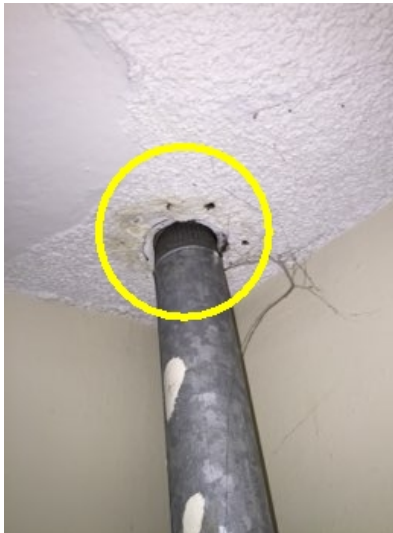
Loose connections noted.

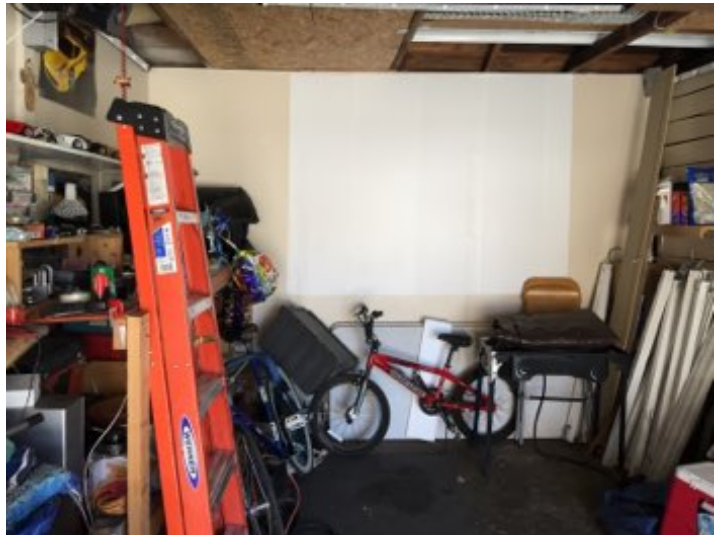
Personal items in garage block complete inspection of all floor, wall and ceiling areas.

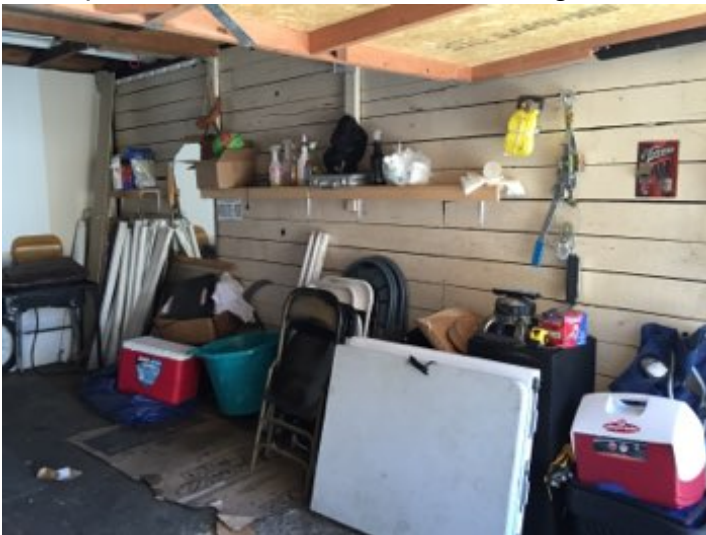
Personal items in garage block complete inspection of all floor, wall and ceiling areas.

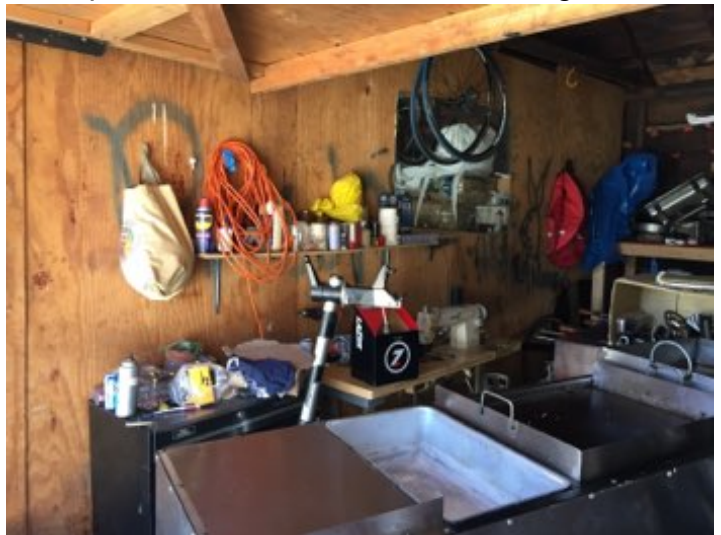
Personal items in garage block complete inspection of all floor, wall and ceiling areas.

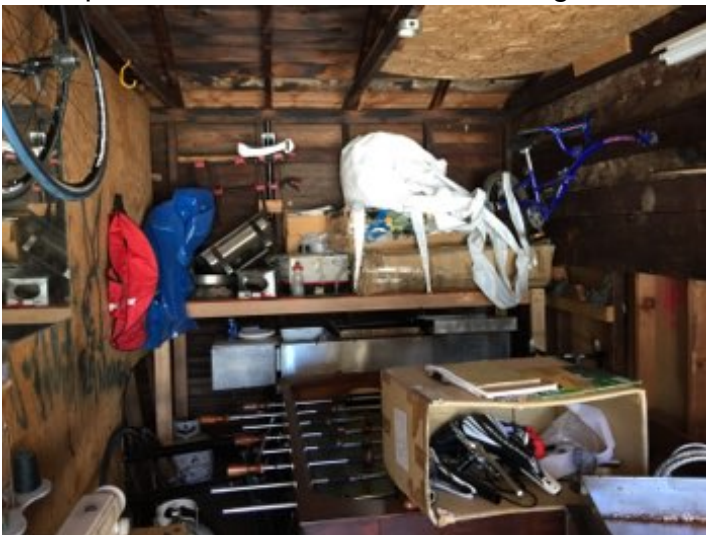
Personal items in garage block complete inspection of all floor, wall and ceiling areas.

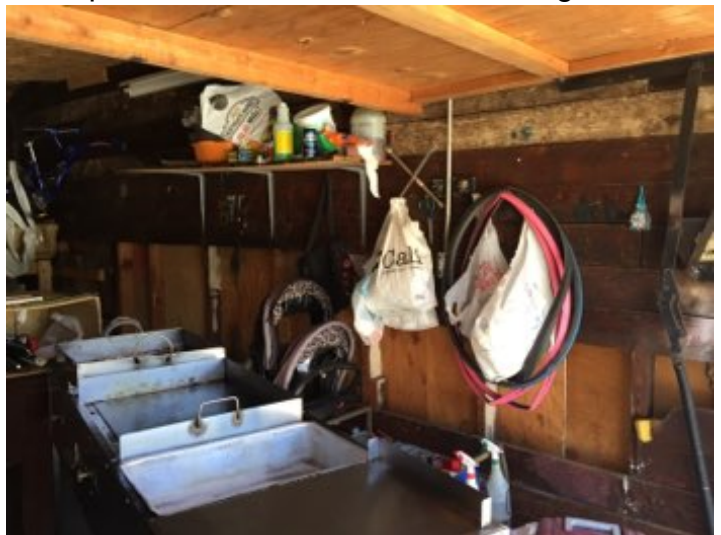
Personal items in garage block complete inspection of all floor, wall and ceiling areas.

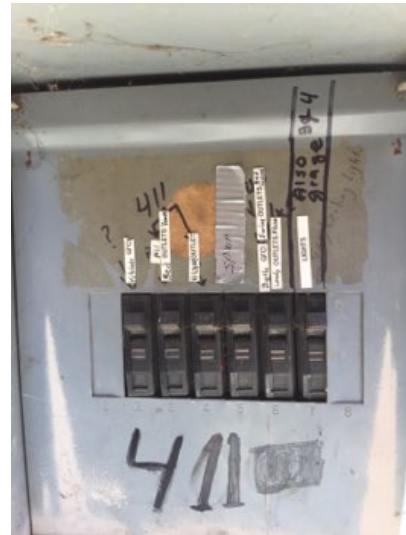
All of the circuit breakers appeared serviceable.

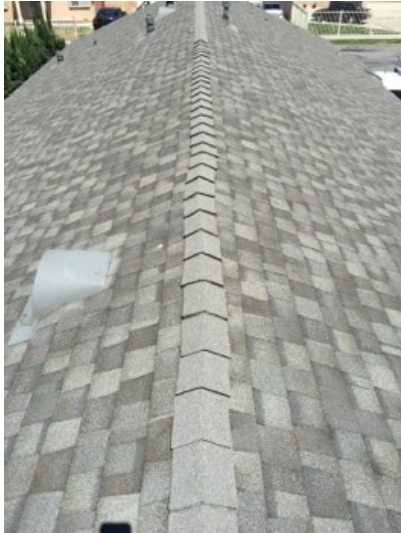
No major system safety or function concerns noted at time of inspection.

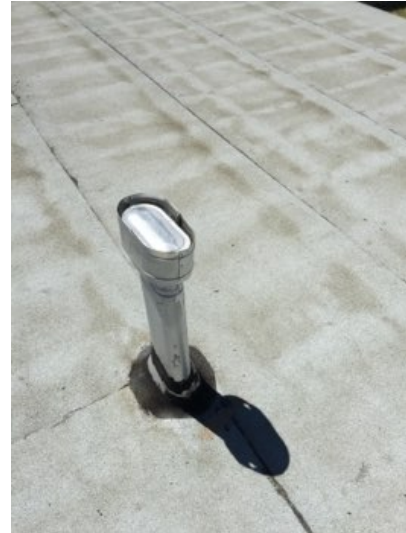
Note that experts recommend that any roof over 10 years old receive a roof certification by a local roofing specialist.

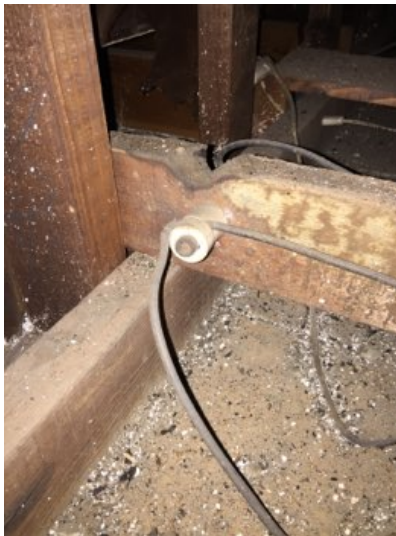
Live knob and tube wiring present.

• ***This property has "knob and tube" wiring which was commonly installed prior to 1950. It is ungrounded, and considered unsafe by today's standards. Over time, the wire's insulation becomes brittle and falls apart, resulting in exposed conductors and a risk of shock and/or fire. This wiring is also easily damaged by covering it with insulation (a common practice), and incorrectly tapping new wiring into it. Some energized knob and tube wiring was found during the inspection. It is not within the scope of this inspection to determine what percentage of this property's wiring is of the knob and tube type or to determine what percentage of the knob and tube wiring is energized vs. abandoned. A qualified electrician should evaluate this wiring and make repairs or replace wiring as necessary.***

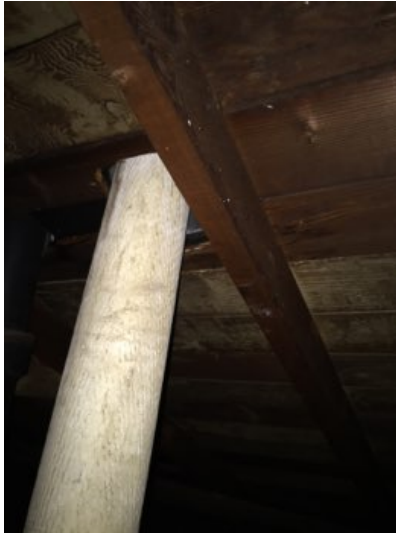
Transite type exhaust pipe observed

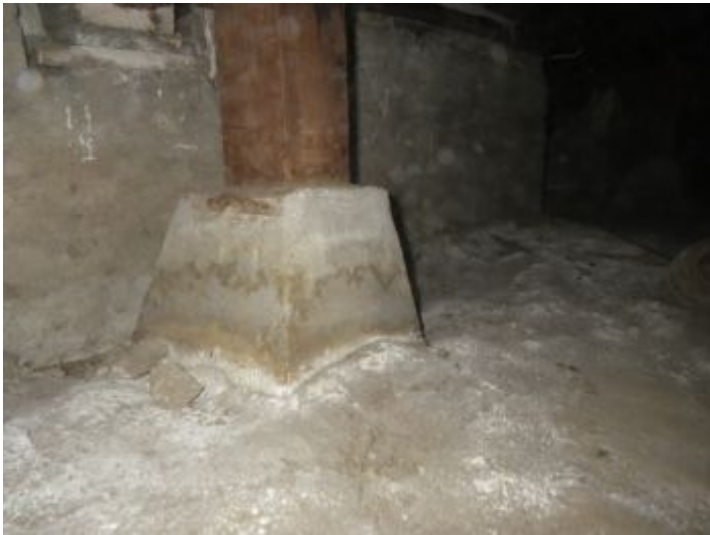
Concrete block/wood piers support floor above.

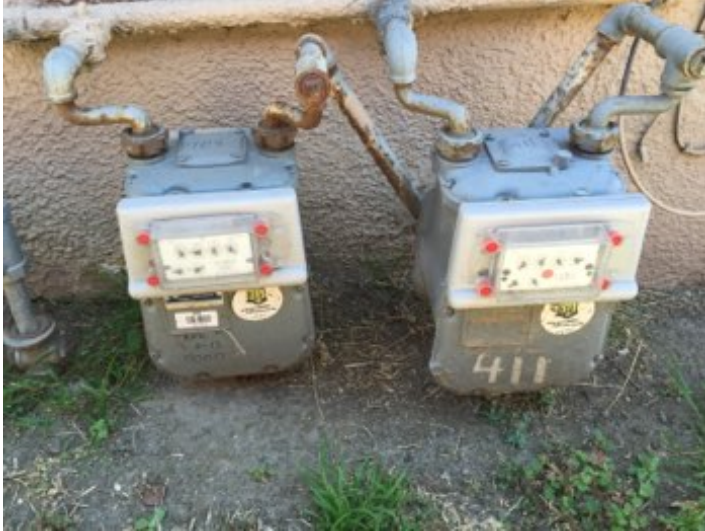
Meter located at exterior. All gas appliances have cut-off valves in line at each unit. No gas odors detected.

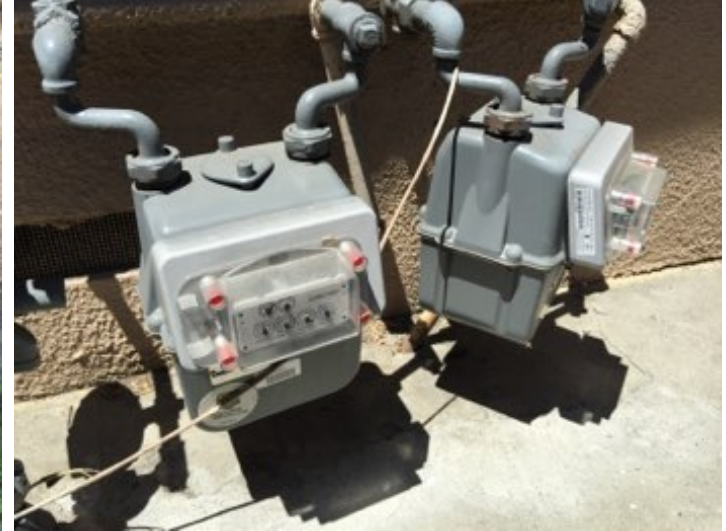
Meter located at exterior. All gas appliances have cut-off valves in line at each unit. No gas odors detected.
