# PROPERTY INSPECTION REPORT

# C.R.INSPECTIONS

1234 Investment Ave. , Your Town , CA  
Inspection prepared for: John and Jayne Doe  
Date of Inspection: 7/14/2015 Time: 2pm  
Weather: Sunny  
SAMPLE REPORT ONLY

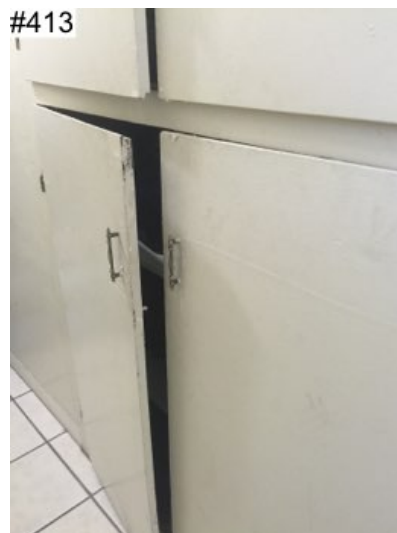
Some cabinet doors need magnets or hardware to stay shut. Repair as needed.

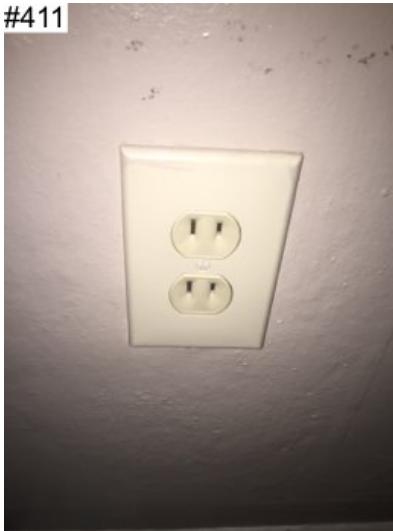
#411

2-prong outlets - The home contained outdated, ungrounded 2-prong electrical outlets. Although this condition may have been commonly considered safe or acceptable at the time the home was originally constructed, as general knowledge of safe building practices has improved with the passage of time, building standards have changed to reflect current understanding. Consider updating the existing condition to meet generally-accepted current standards.

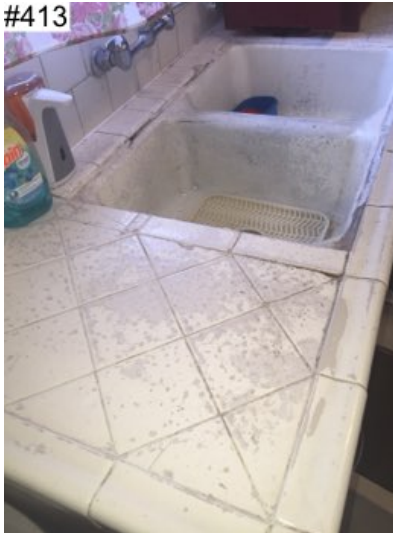
The counter tops are stained. Normal cleaning should take care of this.

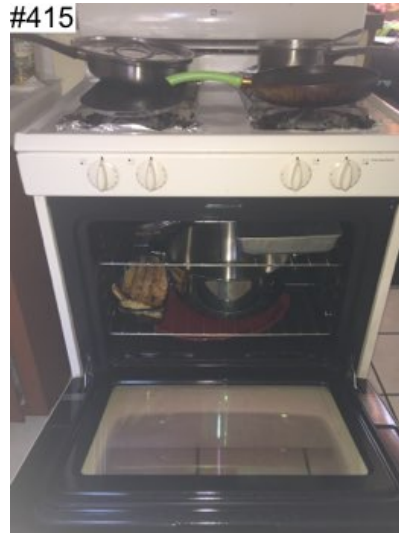
Could not test due to personal items

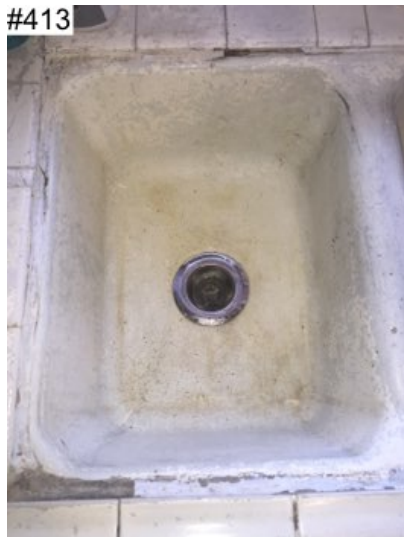
Sink chipped (Cosmetic; does not affect function). Sink chipped (Cosmetic; does not affect function).

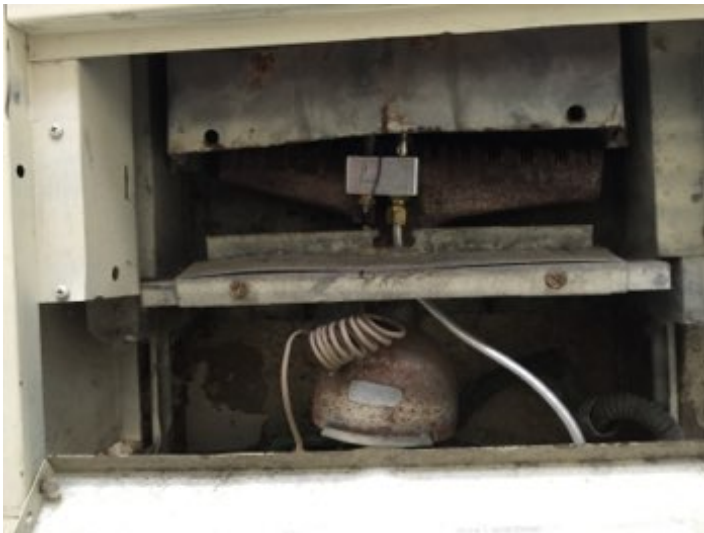
-Pilot not lit; could not test

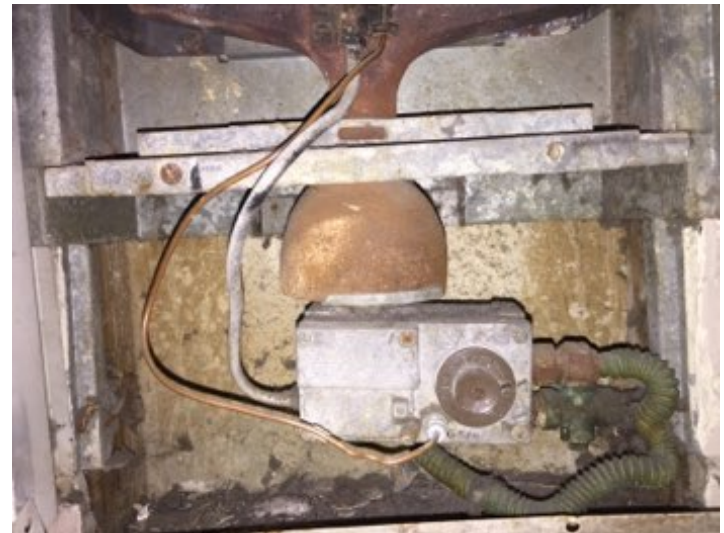
The heating unit has reached its designed life expectancy. We make no warranty, guarantee or estimation as to the remaining useful life of this unit.

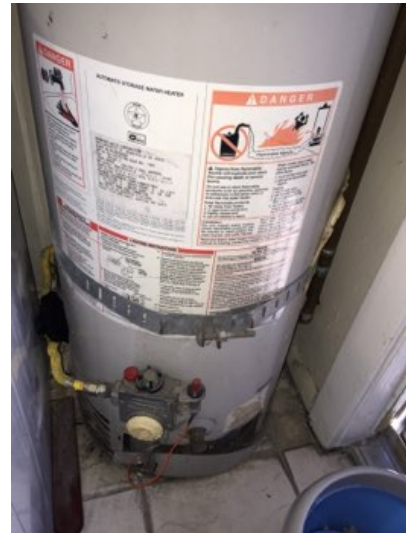
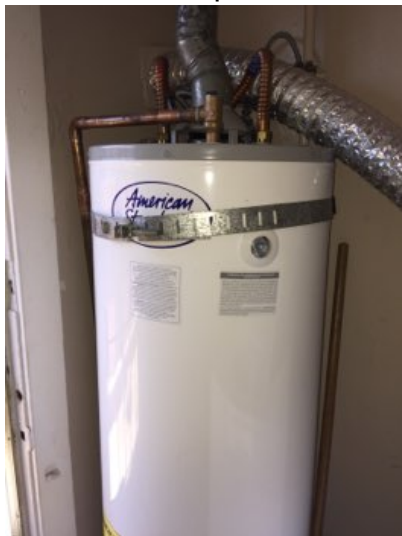
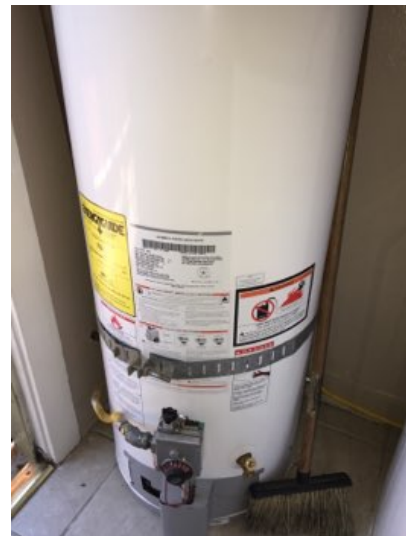
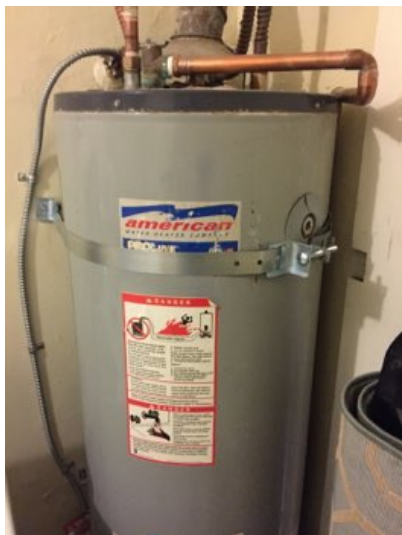
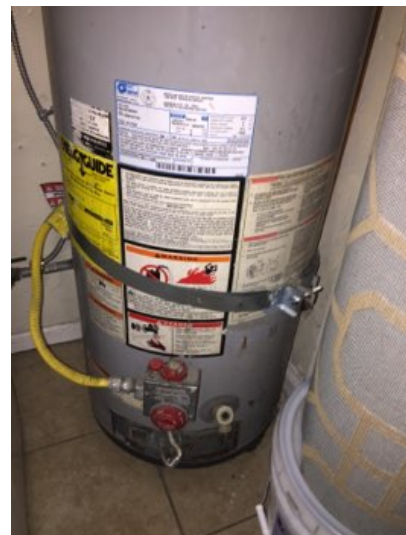
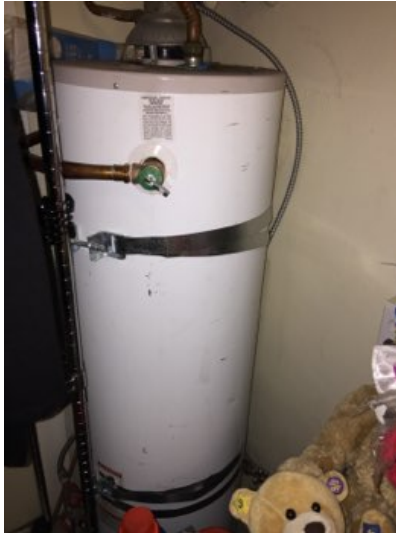
Unit 415

Loose straps noted.

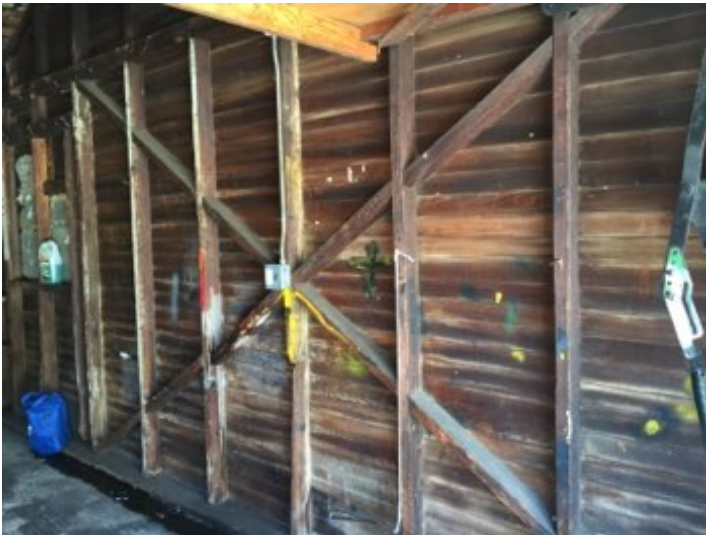
Please consult termite report.

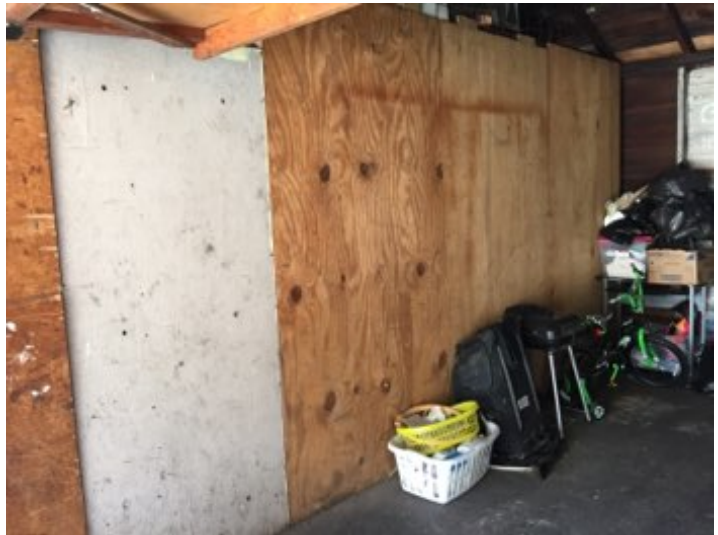
Please consult termite report.

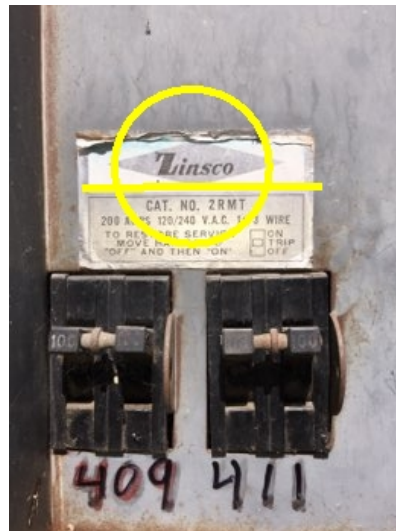
There is a Zinsco service panel present. Zinsco components are prone to problems that can lead to failures, lack of proper protection of circuits and other serious issues, including fire and electrocution. We cannot definitively call this panel defective, but recommend, for your peace of mind, to consult a qualified electrical contractor to get their opinion on this matter. You can learn more about this issue at <http://www.inspect-ny.com/electric/zinsco.htm>

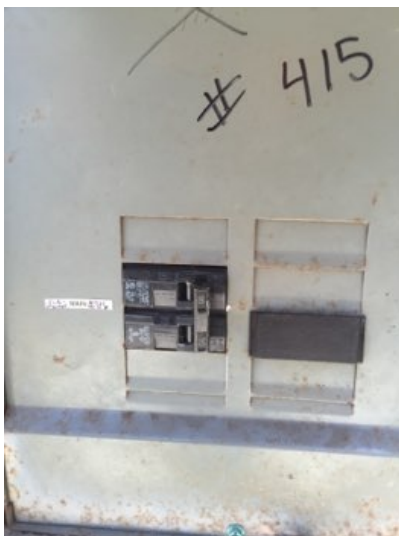
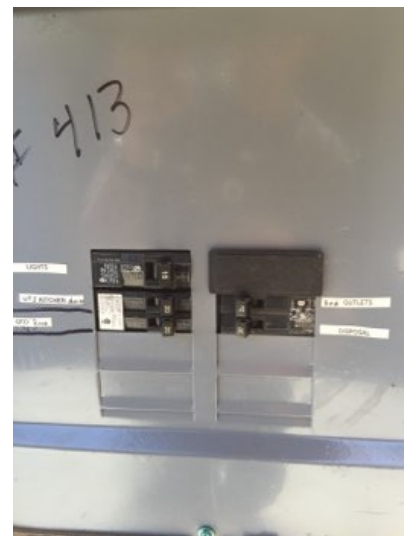
All of the circuit breakers appeared serviceable.

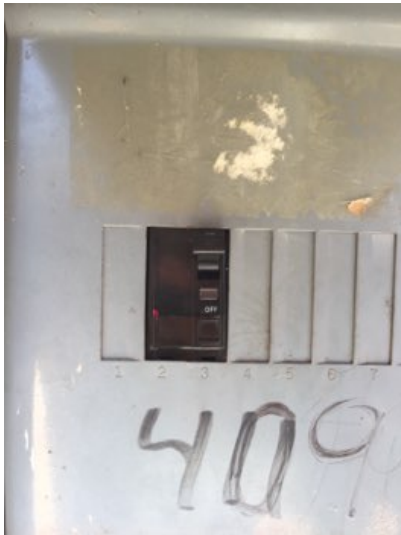
All of the circuit breakers appeared serviceable.

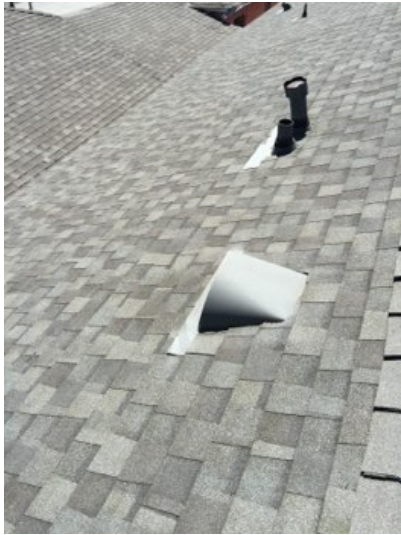
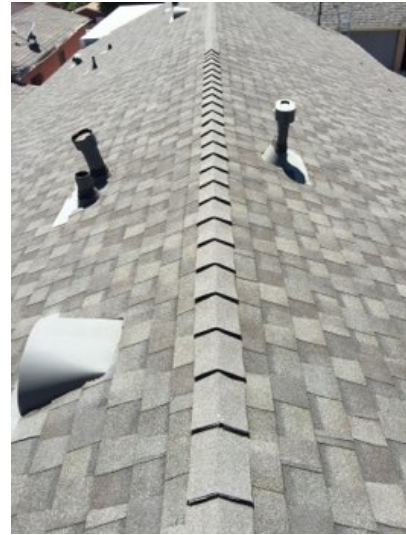
No major system safety or function concerns noted at time of inspection.

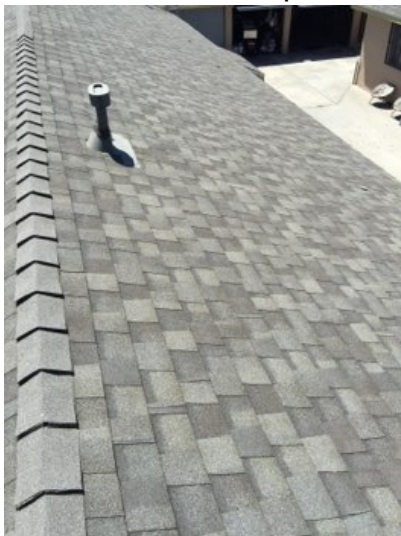
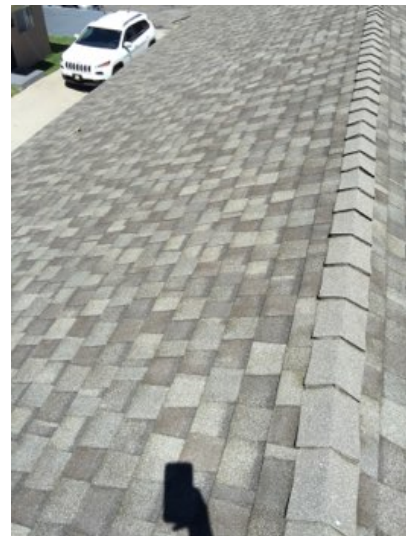
Note that experts recommend that any roof over 10 years old receive a roof certification by a local roofing specialist.

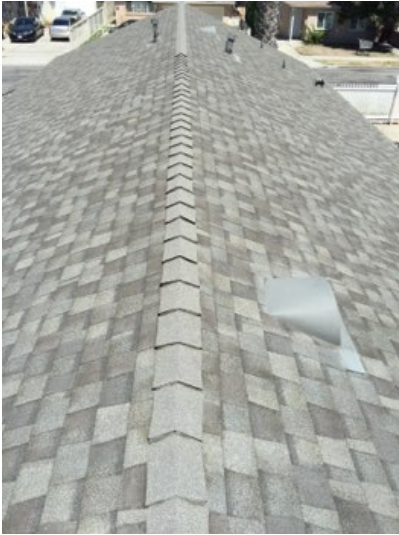
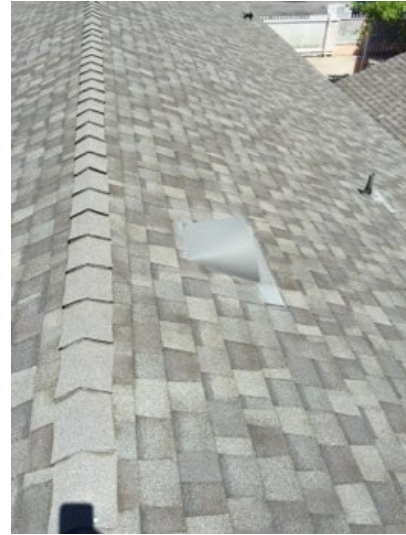
No major system safety or function concerns noted at time of inspection.

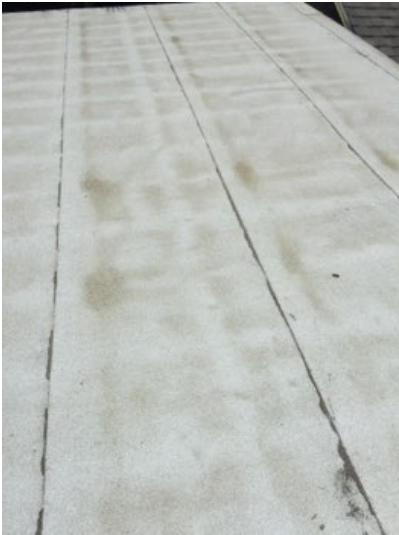
Note that experts recommend that any roof over 10 years old receive a roof certification by a local roofing specialist.

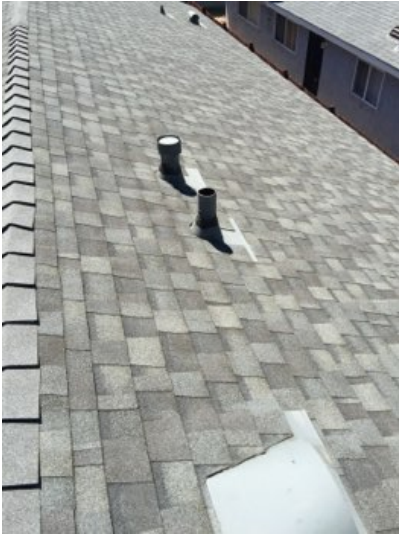
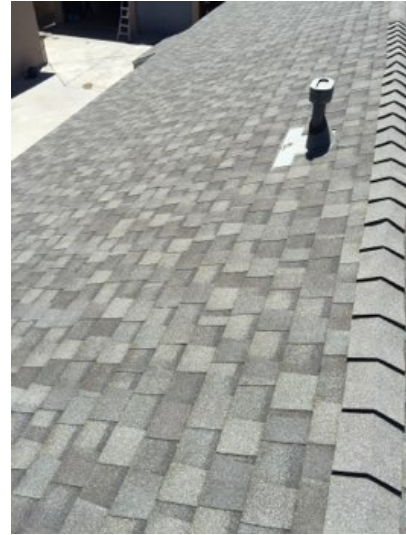
No major system safety or function concerns noted at time of inspection.

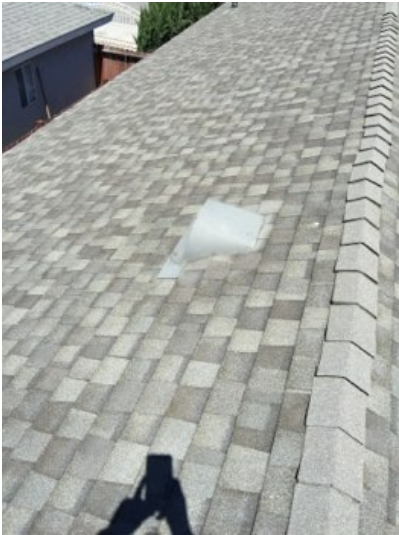
Note that experts recommend that any roof over 10 years old receive a roof certification by a local roofing specialist.

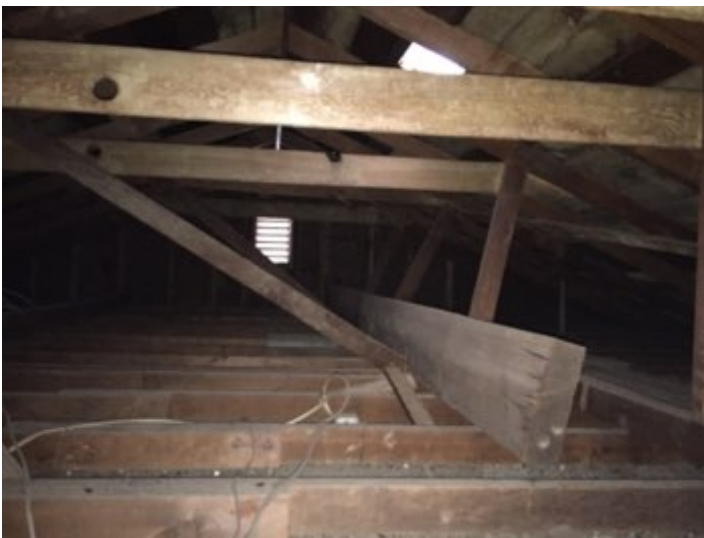
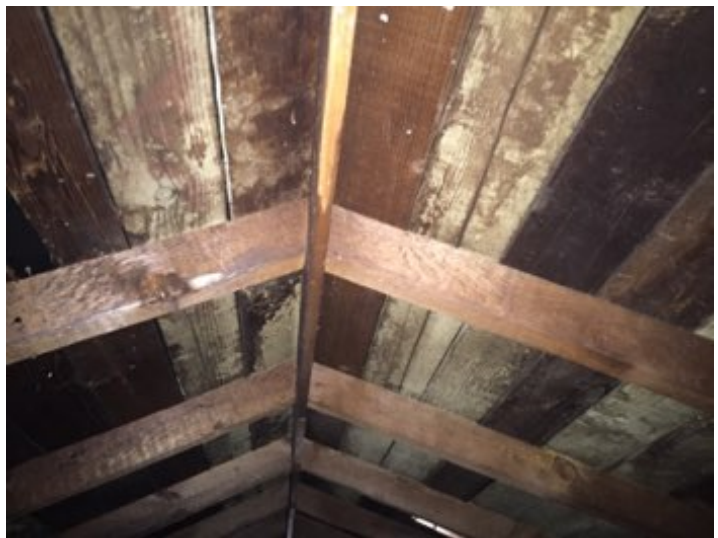
- Evidence of past or present leaks, dry at time of the inspection. Monitor for leaks &/or have roofing contractor evaluate.
- Inspected from access hole only, limited space in attic prevented entry.

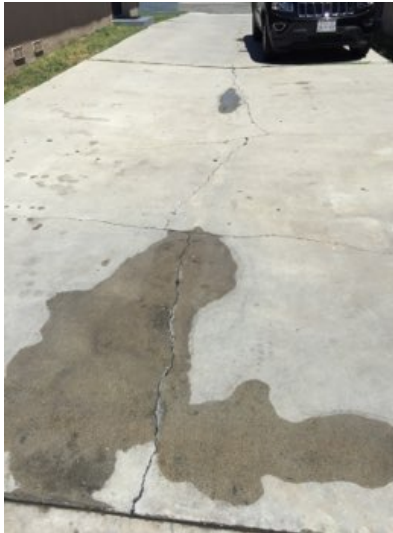
Minor settlement or "hairline" cracks in driveways are normal to properties of any age. They should, however, be monitored for expansion and sealed as necessary.

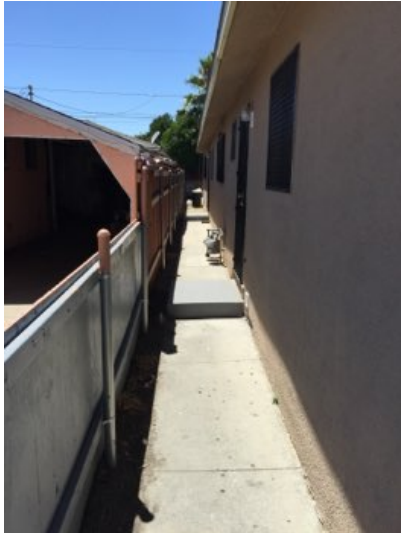
No major system safety or function concerns noted at time of inspection.
